Leland Limited, Inc South Plainfield, New Jersey 908-561-2000

Service Bulletin No. 11-60610

April 15, 2011

Models Affected: EMERGENCY STROBE LIGHT I, XENON
60610, 60610M, 60607, 60646M, 60646, 60647, 60647M

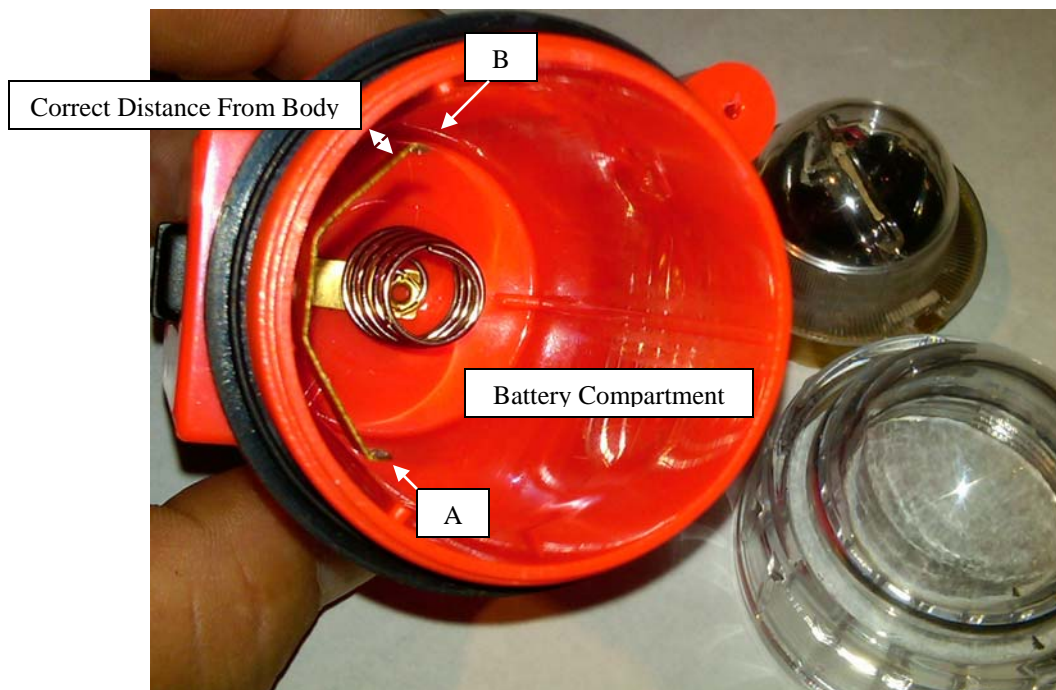
Background: Several customers have reported intermittent failures of the strobe module not firing. With a new battery inserted and the switch in the on position, the strobe should begin to fire (flash) within 2 seconds. Although no mechanical defect has been found, the following is a recommended self repair-adjustment to solve the issue.

1. Remove the lens, module and the battery
2. Look inside the battery compartment and identify two (2) brass contacts marked "A" and "B" in the picture.
3. Gently pry both contact "A" and "B" away from the body and toward the inside of the battery cavity.
4. Only move these contacts about 0.185", about 1/4 of an inch.
5. When you put the battery back in the unit be careful to clear these contacts.
6. Replace the module by touching the side of the module against these contacts first.
7. Reassemble the unit with the lens firmly in place.
8. Test function. If this does not resolve the issue, please contact us, 908-561-2000.
